Concordia
SP-2013-0476C
Site Photos

**Re: Varlance Request Letter – Cut and Fill
Concordia University Texas - Site Plan Application SP-2013-0476C
11400 Concordia University Drive
Austin, Texas 78726**

Please accept this letter as a request for a variance to the Lake Austin Ordinance #840301-F, Sections 9-10-409(A) and 9-10-409(B) for a max cut of +/- 9.25 ft and a max fill of +/- 14.85' for the above referenced project.

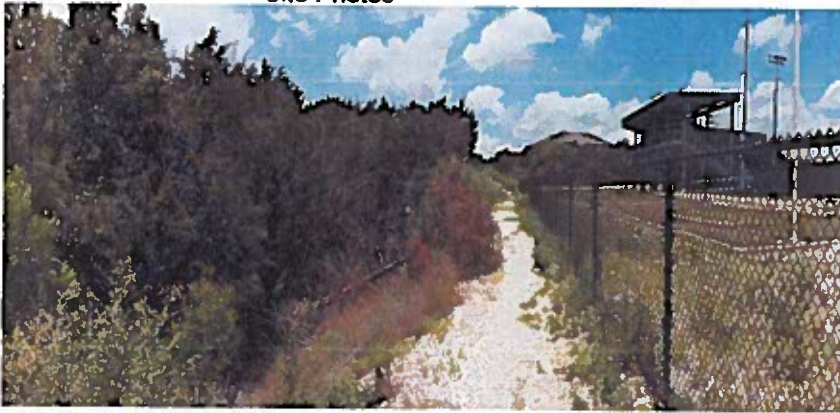
Area of fill between new softball field and existing baseball field to match fill left from that construction looking west

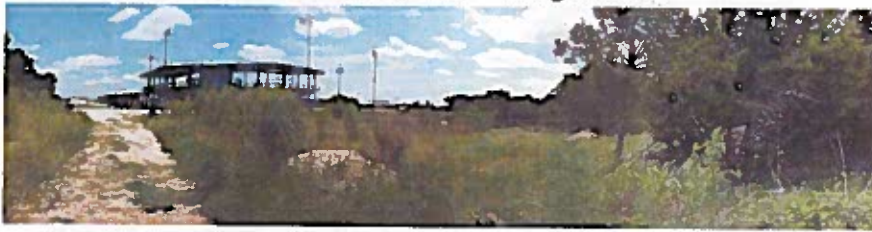
Area of proposed cut for new softball field looking north

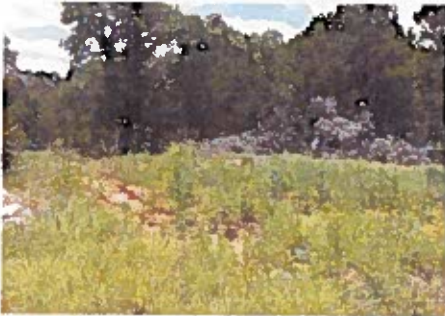
Area of proposed cut and fill within southern detention/water quality pond looking east

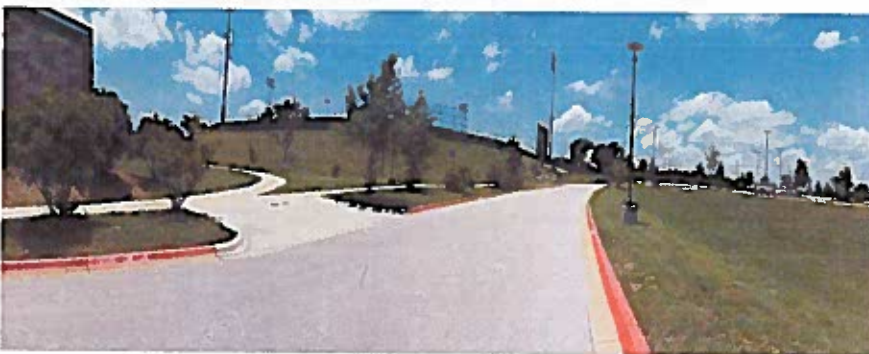
Example of fill approved with the previous variance granted for the baseball field

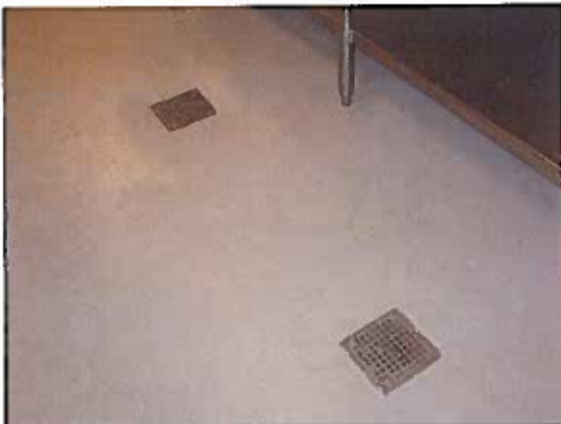
Interior floor drains were observed throughout the site at the time of the site reconnaissance. No spills or releases were observed in the vicinity of the observed floor drains. According to Mr. Cherry, the floor drains located in the office buildings and cafeteria discharge into the sanitary sewer and the floor drains located in the restroom facilities near the recreation area discharge into a septic system. Please see below for further discussion of the septic system. Based on this information, the floor drains do not appear to constitute RECs in connection to the site.

Photo 5 Typical view of interior floor drains.

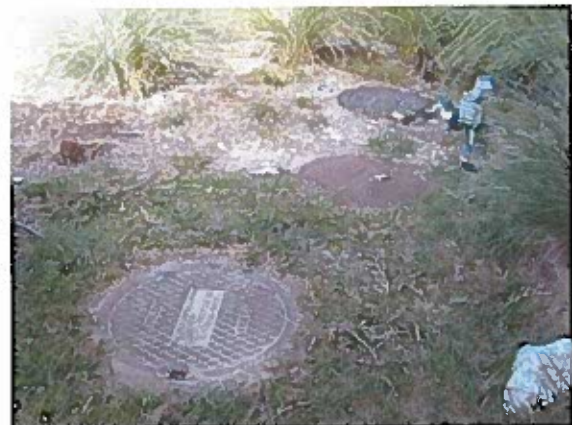
A subgrade cooking grease trap system (unknown capacity) is located outside and southwest of Building E. According to Mr. Cherry, the grease trap system was cleaned out in January 2006 and he is not aware of any problems. No evidence of releases was observed in the vicinity of the grease trap system at the time of the site reconnaissance. Based on site observations and this information, the cooking grease trap system does not appear to constitute a REC in connection to the site at this time.

Photo 6 View of the grease trap located next to Building E, cafeteria.

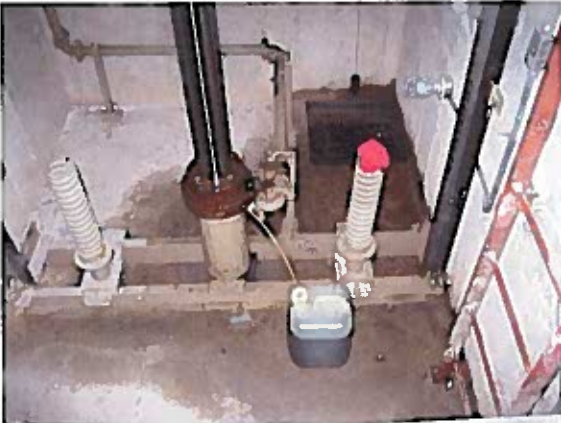
staining was observed within the three hydraulic elevator pits. Based on the minimal nature of the releases and the relatively low impervious nature of concrete, the staining appears to be a *de minimis* condition that does not constitute a REC in connection with the site at this time. When no further use is intended, the elevator components should be removed and disposed of in accordance with applicable regulations. Terracon has found that there is a high incidence of hydraulic fluid releases from elevators with underground hydraulic components; however, these releases usually affect relatively small amounts of native soil and rarely result in groundwater impact. In Terracon's opinion, evaluation of the elevators using soil borings is of limited value; therefore, the subsurface conditions around the vicinity of the elevators should be evaluated only after the elevators are removed.

Photo 7 Typical view of elevator pit with concrete staining.

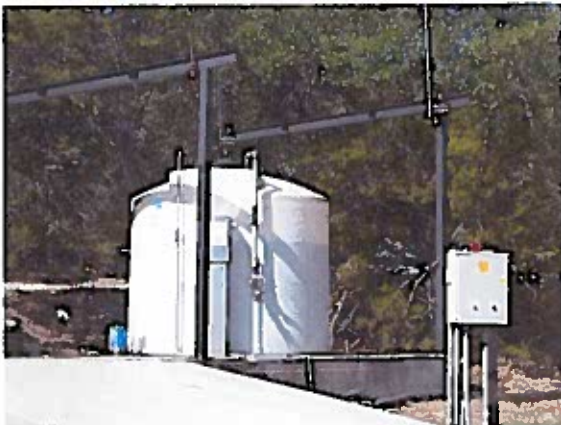
At the time of the site reconnaissance, a large plastic above ground storage tank (AST) of deodorizer was observed on a concrete slab to the northwest of Building B. According to Mr. Cherry, the AST is maintained by US Filter and discharges into the sanitary sewer to control the odor. At the time of the site reconnaissance, a release was observed around the AST. Based on the nature of its contents, the release does not appear to constitute a REC in connection to the site; however, the AST should be repaired to minimize future releases.

Photo 9 View of deodorizer AST.

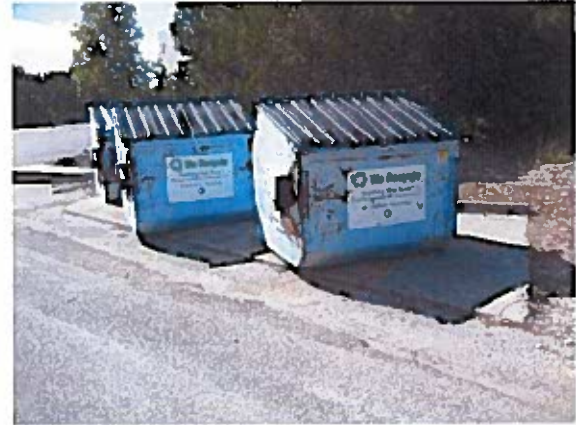
At the time of the site reconnaissance, two roll off dumpsters and four solid waste dumpsters (managed by Accurate and Texas Disposal Systems) were identified. No hazardous materials were observed in or around the dumpster at the time of the site reconnaissance. Minor concrete discoloration was observed in the vicinity of the solid waste dumpster at the time of the site reconnaissance. Based on the minimal area affected and the relatively low impervious nature of concrete, the discoloration appears to be a *de minimis* condition that does not constitute a REC in connection with the site at this time. Based on site observations, the dumpsters do not appear to constitute RECs in connection to the site at this time.

Photo 10 Typical view of solid waste dumpsters.

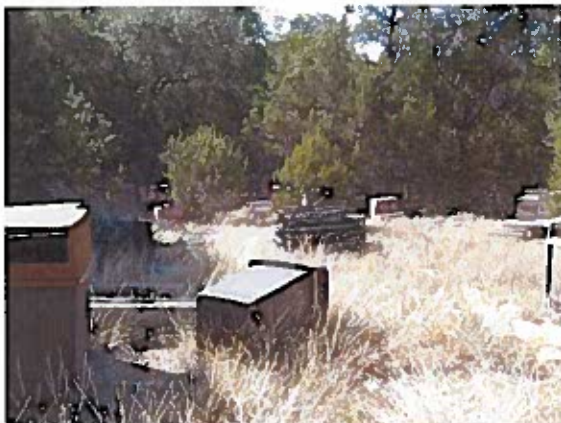
At the time of the site reconnaissance, trash/debris (including, but not limited to, trash cans, wood pallets, granite rocks, pieces of concrete slabs, landscaping debris, and gravel piles) were observed on Lot 1 and the northwestern portion of Lot 2. According to Mr. Cherry, the gravel piles are excess material from trenching activities associated with renovations to the HVAC systems. No spills, releases, distressed vegetation, or noxious odors were observed associated with the trash/debris at the time of the site reconnaissance. Based on site observations, the trash/debris does not appear to constitute RECs in connection to the site at this time. It should be noted that the trash/debris should be removed and disposed of in accordance with applicable regulations.

Photo 11 Typical view of trash/debris located on the northwest portion of Lot 2.

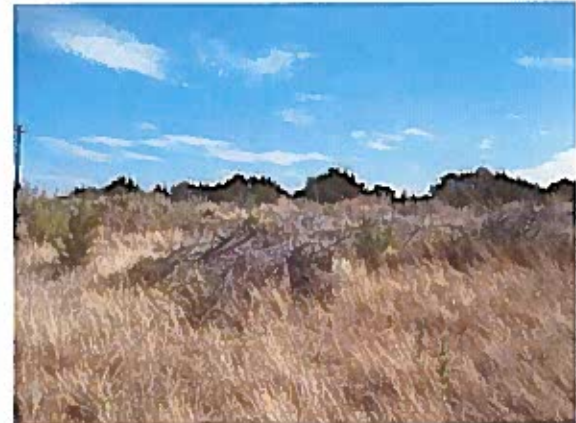
Photo 12 Typical view of trash/debris located on Lot 1.

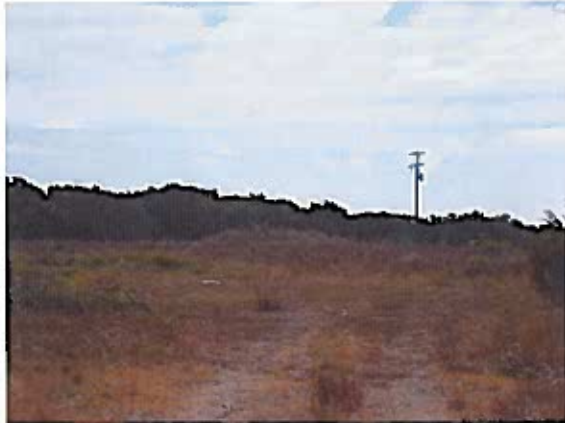
time of the site reconnaissance, a large pile of soil was observed on Lot 1 which was reportedly used to fill in the hole during the removal of the septic system. No noxious odors or distressed vegetation was observed in the vicinity of the septic systems. Based on the operational history of the septic systems (non-manufacturing or production), the septic tanks and/or leach fields present on site would not appear to constitute a REC in connection with the site. However, if no further use is intended, the septic system on Lot 4 should be removed/abandoned in accordance with applicable regulations.

Photo 13 Typical view of former septic system area on Lot 1.

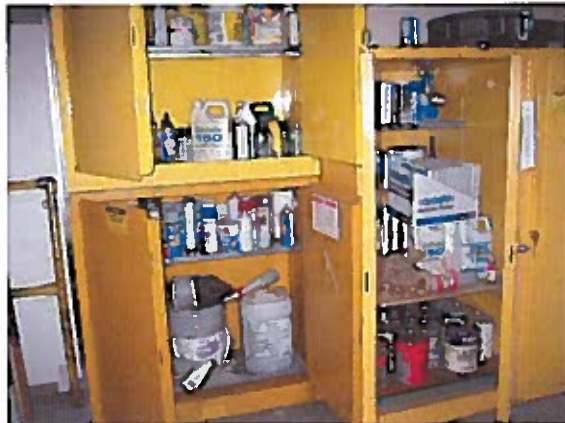
At the time of the site reconnaissance, spray paints, paints, and thinners were observed within flame retardant cabinets located in Building B. These materials appeared to be in good condition, stored in small volume, and in their original containers. Based on their observed condition, they do not appear to constitute a REC in connection with the site at this time.

Photo 15 View of flame retardant cabinets located in Building B.

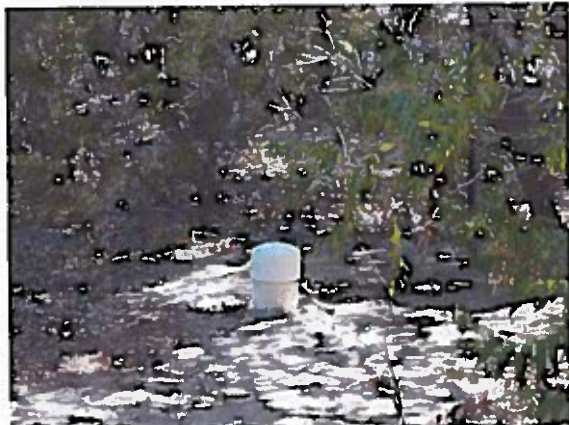
At the time of the site reconnaissance, the site was equipped with two water wells which have reportedly been capped. One water well was observed near the parking lot area just west of Building A and the other was located near the recreation area. If the water wells are likely to be used in the future, they should be tested by a licensed laboratory to evaluate water quality. If no further use is intended, they should be plugged in accordance with the Texas Water Well Driller's Rule 30 TAC 338.48, and a plugging report be filed with the State of Texas Water Well Driller's Board.

Photo 19 View of water well located near Building A.

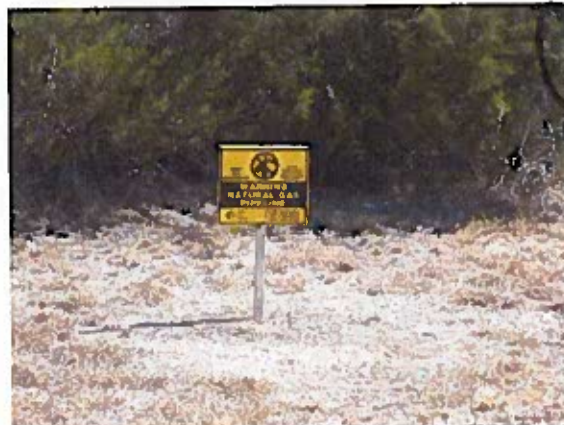
At the time of the site reconnaissance, a Texas Gas Service natural gas pipeline marker was observed along the driveway on the western portions of the site. Based on site observations, the marker appeared to be associated with a natural gas distribution line to nearby structures. No spills, releases, noxious odors, or distressed vegetation were observed in the vicinity of the marker at the time of the site reconnaissance. Based on the physical properties of natural gas (not a liquid at standard pressure and temperature) and site observations, potential releases of this material are not likely to constitute a REC in connection with the site.

Photo 20 View of natural gas pipeline marker.

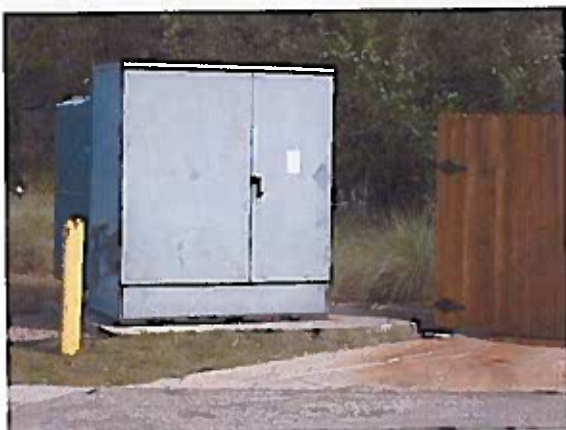
Two unlabeled pad-mounted electrical transformers and two unlabeled pole-mounted transformers, owned by Pedernales Electric Cooperative (PEC), were observed during the site reconnaissance. The on-site pad- and pole-mounted transformers appeared to be in good condition, and no evidence of dielectric fluid leakage was observed on or below the units at the time of the site reconnaissance. PEC has acknowledged responsibility for cleanup of PCB or non-PCB spills for the transformers. Based on this information, the on-site transformers do not appear to constitute a REC in connection with the site.

Photo 21 Typical view of pad-mounted transformer.

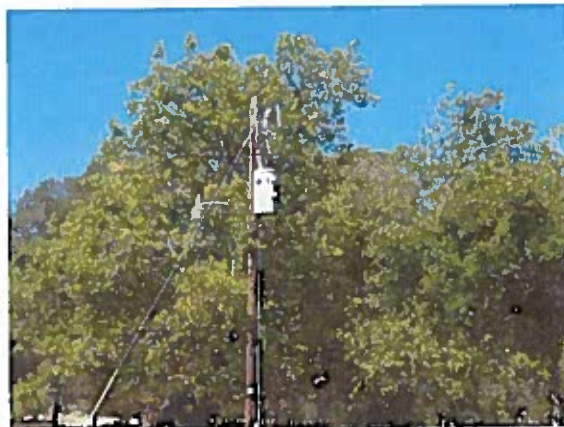
Photo 22 Typical view of pole-mounted transformer.
